## LEAD-BASED PAINT INSPECTION AND RISK ASSESSMENT REPORT

[REDACTED]  
Highland Park, Michigan

February 1, 2012

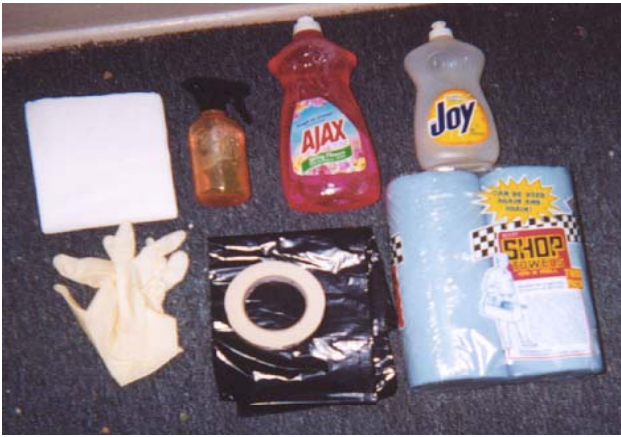
## Step 1 - Supplies

Gloves, absorbent throw-away wipes or towels, garbage bags, spray bottle with liquid detergent and water, disposable towels and mop. Children should not be present while cleaning.

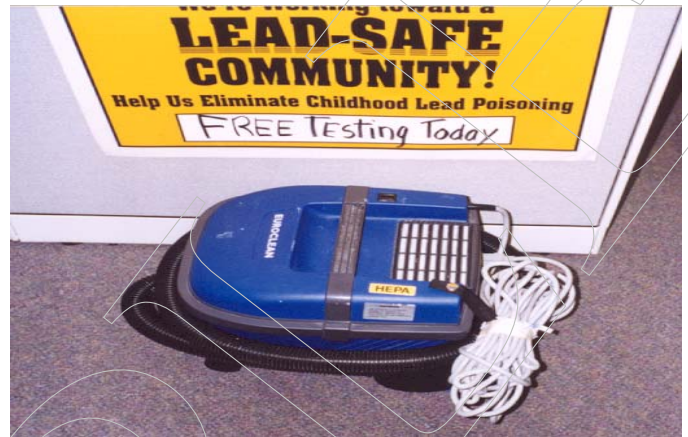
## Step 2 – HEPA Vacuum

HEPA vacuum obtained from your local health department. A regular vacuum is NOT recommended. CAUTION: Do not open, change bag, or empty contents inside the home.

\* A HEPA vacuum has a high efficiency particulate air filter built in that catches fine lead dust. This filter catches up to 99% of the dust and dirt sucked into the vacuum. The HEPA vacuum should meet ANSI Z9.2 standards and OSHA and EPA regulations. Check the vacuum or owner's manual.

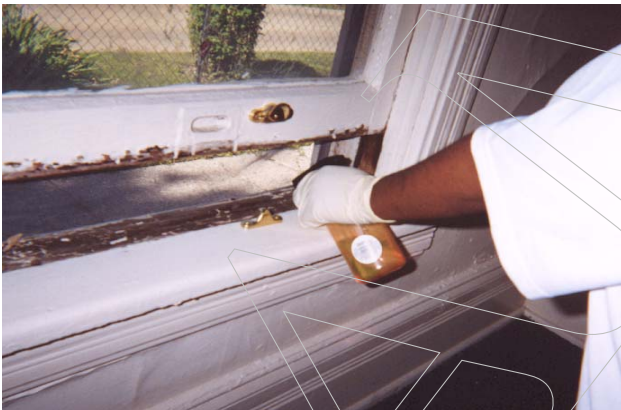
## Step 3 – Wet Surfaces

HEPA\* vacuum windows, floors, and porches, and then mist lightly with the soap solution. If a HEPA is not available, carefully remove dirt and paint chips with a wet towel. Replace towels until the surface is clean.

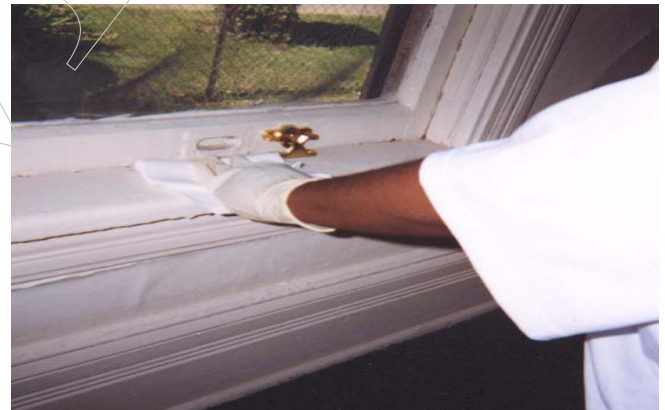
## Step 4 – Clean Surfaces

Wipe surfaces clean by applying pressure. This has proven to be effective in removing lead dust.

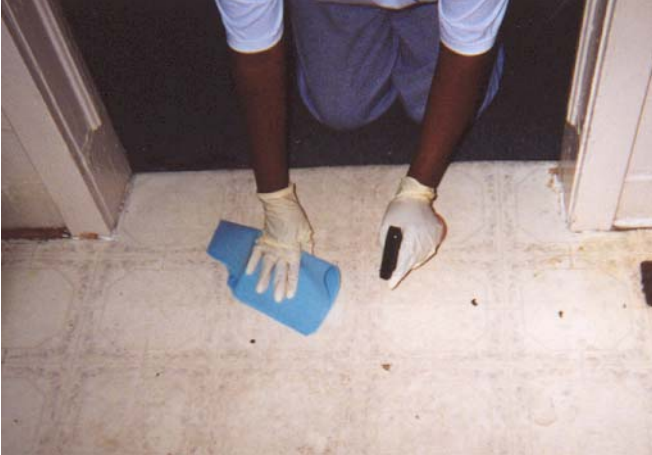
## Step 5 – Wipe Floors

Misting with the soap solution and then wiping with towels is the best way to remove lead dust.

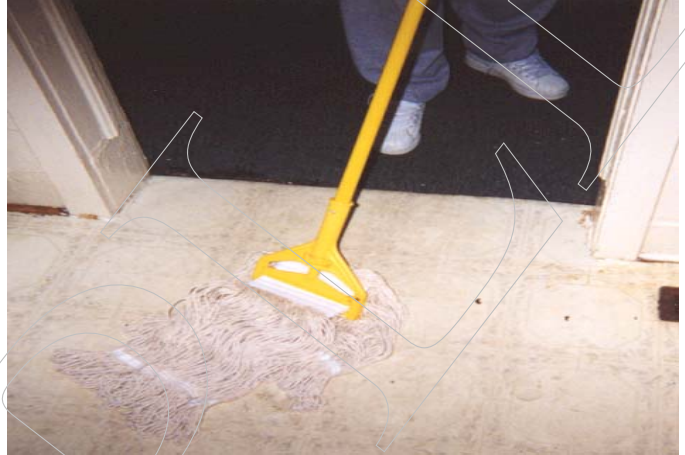
## Step 6 – Mop Floors

A second choice is to damp mop vinyl and wood floors with the soap solution. Start at the back of the room and work toward the exit door. This way is not as good as Step 5.

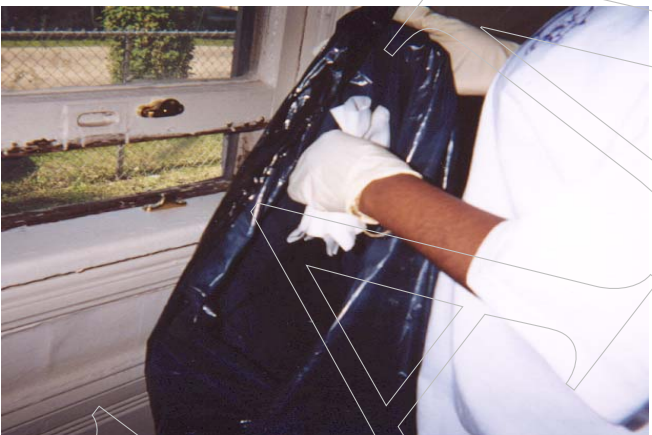
## Step 7 – Bag It

Change towels often until no paint chips or dirt can be seen. Put them in a garbage bag, and seal with tape or a knot. The bag can be put out for normal trash pickup.
